# G-RIB

Repairs to treads and pallets on site

### **EFFICIENT REPAIRS ON SITE WITH G-RIB**

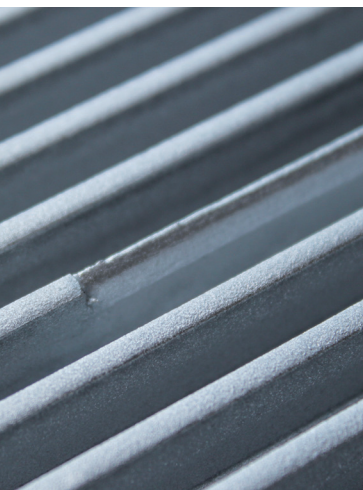
Before

Mulder Montage has developed a method for repairing worn ribs on the standing areas of escalator steps and moving walk pallets. This patented method is based on repairing damage using a filler material, returning the worn rib to its original form.

According to NEN-EN115 standards, the ribs on the standing areas of escalator steps and moving walk pallets must comply with requirements for minimal dimensions. This is in the interests of safety for the users. Various external factors (such as stones trapped between comb plates) can cause damage to the ribs and pallets, so that they no longer meet the dimensional requirements. Damage will be detected during periodic inspections and must be rectified before the installation can be approved under NEN-EN115 standards.
